**Flood Control Project Maintenance  
Levee Inspections**

## Maintenance Issue Types Only, Levee Inspection Report By Mile - Spring 2015

### Reclamation District No. 2031 Elliot

Waterway	Bank	Unit Miles	Inspection Start/End	Inspector
Unit No. 01 Stanislaus River	Left	7.07	03/17/2015 03/17/2015	Maksim Khashchuk

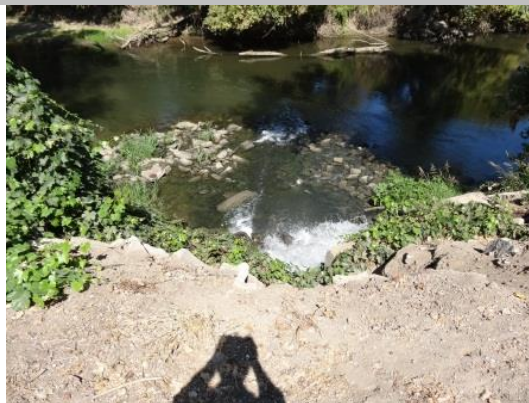
Photo 1 of 1 : SP\_2015\_RD2031\_307\_1\_20150317\_00001.jpg

LM Start	0.46	Rating **	M	Issue No.	1
LM End	0.46	Issue Type +	Ma	Location *	WS
Category	Supplemental			GPS Latitude/Longitude	
				Start	End
Item	DWR Erosion Survey			37.704740 °	37.704740 °
				-121.159140 °	-121.159140 °
DWR ID	DWR_RD2031_01_s _ 2015_1				
Action/Comments					
Inspector Comments: 07/31/2014: No significant change observed. 09/10/2013: No significant change observed. 07/18/2012: No significant change observed. 08/18/2011: No significant change observed on site. Debris that blocks the irrigation outlet is visible. 10/19/2010: No significant change observed on site. Sloughing of the bank is occurring adjacent to an irrigation outlet structure. There is moderate to heavy vegetation along the bank that is well established. Broken chunks and slabs of concrete are used as rip rap and line the outside of the irrigation outlet structure. However, much of the rip rap along the slope is sloughing and could possibly lead to future slope instability. 08/05/2010: Recommended as a local maintenance issue, per CLRO. 08/20/2009: No major change observed since last visit; 1 inch fissure cracks developing on the slope; rip rap is showing signs of sloughing; recommend as local maintenance issue; site was previously rated "U". 2008: No change from previous year; irrigation outlet located on site; rip rap placed on river bank. 09/06/2007: Near agricultural diversion; only 3' landside height differential. [2014 Site ID:RD2031U01RM0.48]

Looking down at the site. The irrigation outlet is operating. Debris is visible at the outlet.

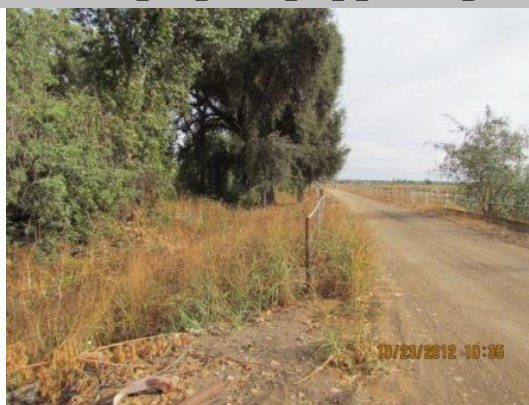
Photo 1 of 2 : SP\_2015\_RD2031\_307\_2\_20150317\_00002.jpg

View of vegetation on waterside slope. Facing upstream.

LM Start	0.51	Rating **	M	Issue No.	2
LM End	0.51	Issue Type +	Ma	Location *	WS
Category	Earthen Levee			GPS Latitude/Longitude	
				Start	End
Item	Vegetation			37.704050 °	37.704050 °
				-121.159578 °	-121.159578 °
DWR ID	DWR_RD2031_01_s _ 2012_2				
Action/Comments					
Remove the wild growth other than native grasses from the levee slopes.					
Inspector Comments: Remove vegetation 20 feet away from the levee crown.

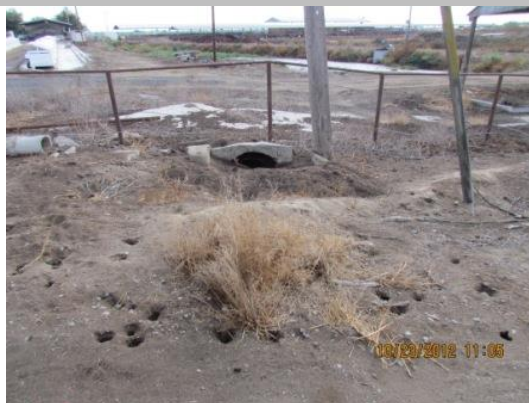
Photo 1 of 1 : SP\_2015\_RD2031\_307\_36\_20150317\_00021.jpg

View of rodent burrows on landside slope.

LM Start	0.77	Rating **	M	Issue No.	36
LM End	0.77	Issue Type +	Ma	Location *	LS
Category	Earthen Levee			GPS Latitude/Longitude	
				Start	End
Item	Animal Control			37.701177 °	37.701177 °
				-121.162055 °	-121.162055 °
DWR ID	DWR_RD2031_01_f _ 2012_36				
Action/Comments					
No rodents visible, but rodent burrows visible; need to backfill and compact or grout burrows.

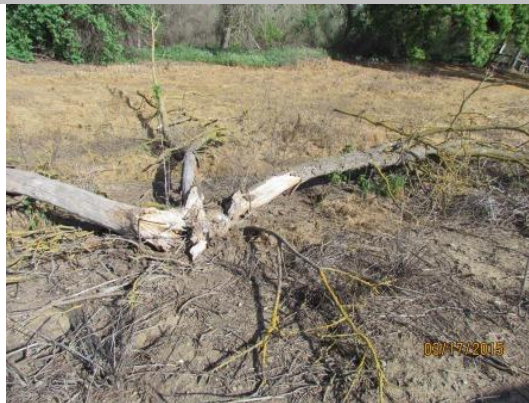
Photo 1 of 1 : SP\_2015\_RD2031\_307\_49\_20150330\_00052.jpg

LM Start	0.91	Rating **	N	Issue No.	49
LM End	0.91	Issue Type +	Ma	Location *	WS
Category	Earthen Levee			GPS Latitude/Longitude	
				Start	End
Item	Trim / Thin Trees			37.699790 °	37.699790 °
				-121.163730 °	-121.163730 °
DWR ID	DWR_RD2031_01_s_2015_49				
Action/Comments					
Tree stumps.

View of the tree stump on the waterside levee slope.

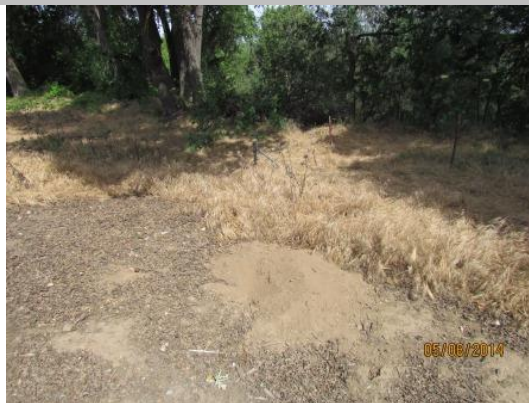
Photo 1 of 1 : SP\_2015\_RD2031\_307\_128\_20150317\_00036.jpg

View of the rodent hole on the waterside levee slope.

LM Start	1.14	Rating **	M	Issue No.	128
LM End	1.14	Issue Type +	Ma	Location *	WS
Category	Earthen Levee			GPS Latitude/Longitude	
				Start	End
Item	Animal Control			37.698873 °	37.698873 °
				-121.167785 °	-121.167785 °
DWR ID	DWR_RD2031_01_s_2014_128				
Action/Comments					
Exterminate rodents and backfill and compact or grout burrows.

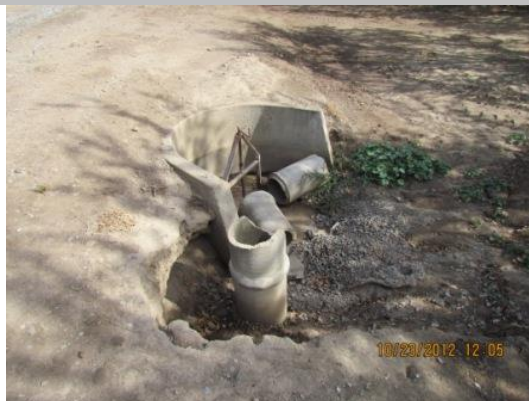
Photo 1 of 2 : SP\_2015\_RD2031\_307\_3\_20150317\_00004.jpg

View of the erosion site on landside slope, facing upstream.

LM Start	1.56	Rating **	M	Issue No.	3
LM End	1.56	Issue Type +	Ma	Location *	LS
Category	Earthen Levee			GPS Latitude/Longitude	
				Start	End
Item	Erosion / Bank Caving			37.698776 °	37.698776 °
				-121.174327 °	-121.174327 °
DWR ID	DWR_RD2031_01_s _ 2012_3				
Action/Comments					
Note and monitor erosion site.					
Inspector Comments: Erosion is active around the irrigation standpipe.

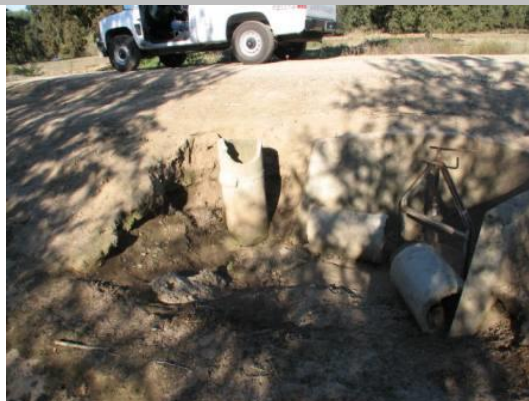
Photo 2 of 2 : SP\_2015\_RD2031\_307\_3\_20150317\_00005.jpg

10/26/2011 Active erosion into the levee prism around irrigation standpipe.

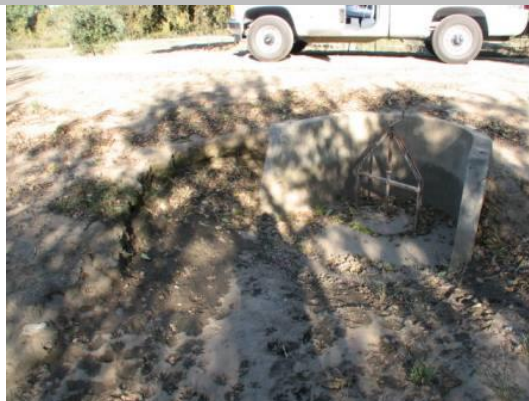
Photo 1 of 1 : SP\_2015\_RD2031\_307\_8\_20150317\_00010.jpg

10/26/2011 Active erosion shown around irrigation inlet.

LM Start	1.58	Rating **	M	Issue No.	8
LM End	1.58	Issue Type +	Ma	Location *	WS
Category	Earthen Levee			GPS Latitude/Longitude	
				Start	End
Item	Erosion / Bank Caving			37.698610 °	37.698610 °
				-121.174598 °	-121.174598 °
DWR ID	DWR_RD2031_01_s _ 2012_8				
Action/Comments					
Note and monitor erosion site.					
Inspector Comments: Active erosion is occurring around irrigation inlet.

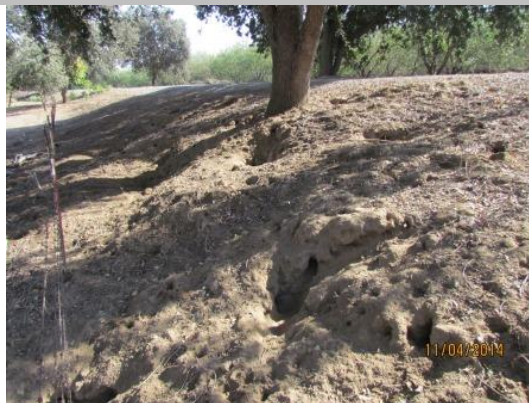
Photo 1 of 1 : SP\_2015\_RD2031\_307\_52\_20150317\_00030.jpg

View of the multiple large rodent hole in the waterside levee slope.

LM Start	1.62	Rating **	A/W	Issue No.	52
LM End	1.62	Issue Type +	Ma	Location *	WS
Category	Earthen Levee			GPS Latitude/Longitude	
				Start	End
Item	Animal Control			37.698334 °	37.698334 °
				-121.175176 °	-121.175176 °
DWR ID	DWR_RD2031_01_f_2013_52				
Action/Comments					
No rodents visible, but rodent burrows visible; need to backfill and compact or grout burrows.

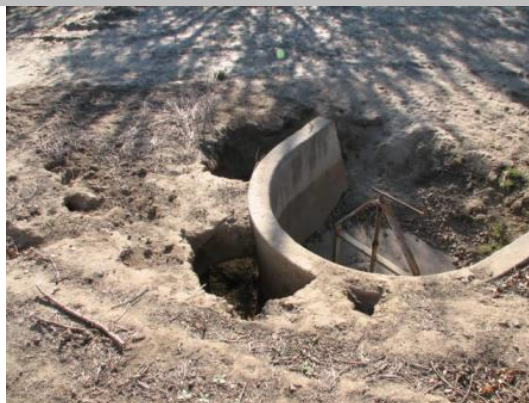
Photo 1 of 1 : SP\_2015\_RD2031\_307\_9\_20150317\_00011.jpg

10/26/2011 Active erosion into levee prism around irrigation inlet.

LM Start	1.63	Rating **	M	Issue No.	9
LM End	1.63	Issue Type +	Ma	Location *	LS
Category	Earthen Levee			GPS Latitude/Longitude	
				Start	End
Item	Erosion / Bank Caving			37.698208 °	37.698208 °
				-121.175400 °	-121.175400 °
DWR ID	DWR_RD2031_01_s_2012_9				
Action/Comments					
Note and monitor erosion site. Inspector Comments: Active erosion around irrigation inlet in levee prism.

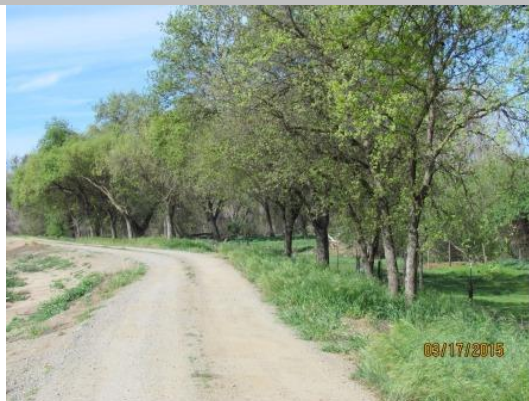
Photo 1 of 1 : SP\_2015\_RD2031\_307\_54\_20150330\_00054.jpg

View of the vegetation on the levee slope.

LM Start	2.53	Rating **	M	Issue No.	54
LM End	2.69	Issue Type +	Ma	Location *	WS
Category	Earthen Levee			GPS Latitude/Longitude	
				Start	End
Item	Vegetation			37.687418 °	37.686816 °
				-121.181536 °	-121.184342 °
DWR ID	DWR_RD2031_01_s _ 2015_54				
Action/Comments					
Control annual grass and weeds on the levee slopes and easements.

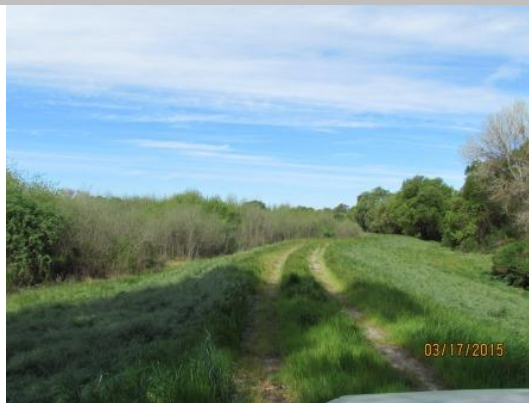
Photo 1 of 1 : SP\_2015\_RD2031\_307\_56\_20150330\_00055.jpg

View of the annual vegetation on the levee crown and slopes.

LM Start	3.73	Rating **	M	Issue No.	56
LM End	4.40	Issue Type +	Ma	Location *	CR
Category	Earthen Levee			GPS Latitude/Longitude	
				Start	End
Item	Vegetation			37.689772 °	37.686397 °
				-121.199569 °	-121.207931 °
DWR ID	DWR_RD2031_01_s _ 2015_56				
Action/Comments					
Control annual grass and weeds on the levee slopes and easements.

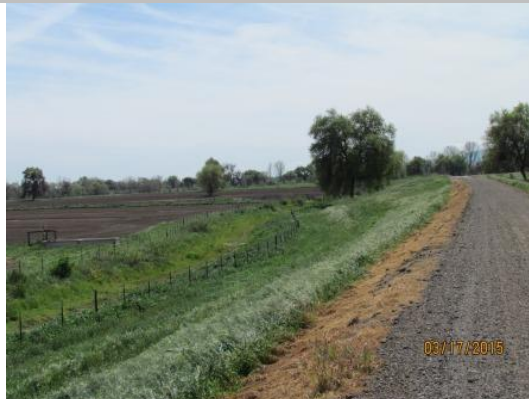
Photo 1 of 1 : SP\_2015\_RD2031\_307\_57\_20150330\_00056.jpg

View of the annual vegetation on the landside levee slope.

LM Start	5.37	Rating **	M	Issue No.	57
LM End	7.07	Issue Type +	Ma	Location *	LS
Category	Earthen Levee			GPS Latitude/Longitude	
				Start	End
Item	Vegetation			37.677346 °	37.661837 °
				-121.217537 °	-121.232954 °
DWR ID	DWR_RD2031_01_s_2015_57				
Action/Comments					
Control annual grass and weeds on the levee slopes and easements.

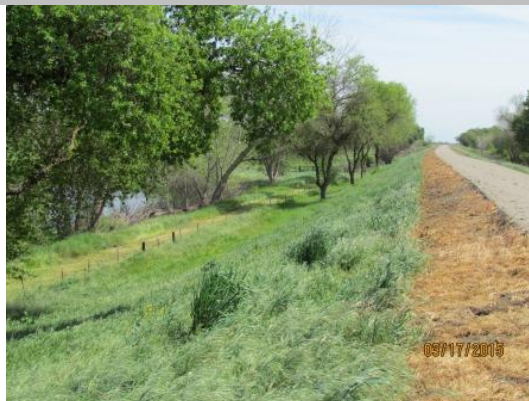
Photo 1 of 1 : SP\_2015\_RD2031\_308\_18\_20150330\_00020.jpg

View of the annual vegetation on the landside levee slope.

LM Start	0.71	Rating **	M	Issue No.	18
LM End	1.40	Issue Type +	Ma	Location *	LS
Category	Earthen Levee			GPS Latitude/Longitude	
				Start	End
Item	Vegetation			37.654134 °	37.648209 °
				-121.230216 °	-121.221174 °
DWR ID	DWR_RD2031_02_s_2015_18				
Action/Comments					
Control annual grass and weeds on the levee slopes and easements.

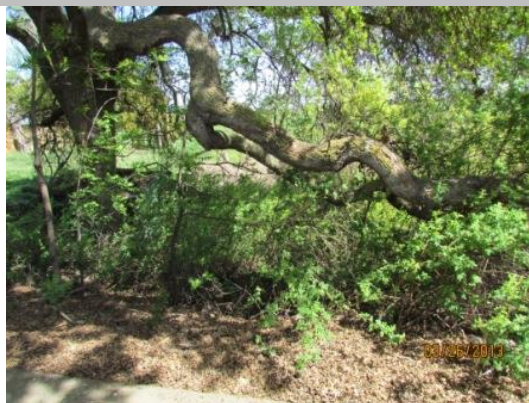
Photo 1 of 1 : SP\_2015\_RD2031\_308\_15\_20150317\_00007.jpg

View of the tree limb obstructing visibility and access to the landside levee slope.

LM Start	1.41	Rating **	M	Issue No.	15
LM End	1.41	Issue Type +	Ma	Location *	LS
Category	Earthen Levee			GPS Latitude/Longitude	
				Start	End
Item	Trim / Thin Trees			37.648080 °	37.648080 °
				-121.221031 °	-121.221031 °
DWR ID	DWR_RD2031_02_s_2013_15				
Action/Comments					
Trim trees to at least five feet above ground level.

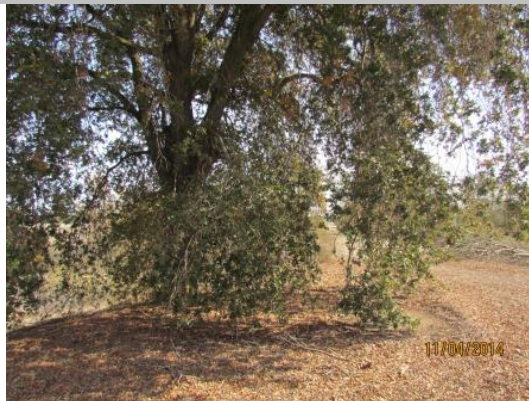
Photo 1 of 1 : SP\_2015\_RD2031\_308\_25\_20150317\_00010.jpg

View of the overgrown tree obstructing visibility and access of the landside levee slope.

LM Start	2.01	Rating **	M	Issue No.	25
LM End	2.01	Issue Type +	Ma	Location *	LS
Category	Earthen Levee			GPS Latitude/Longitude	
				Start	End
Item	Trim / Thin Trees			37.640874 °	37.640874 °
				-121.223870 °	-121.223870 °
DWR ID	DWR_RD2031_02_f_2014_25				
Action/Comments					
Trim trees to at least five feet above ground level.

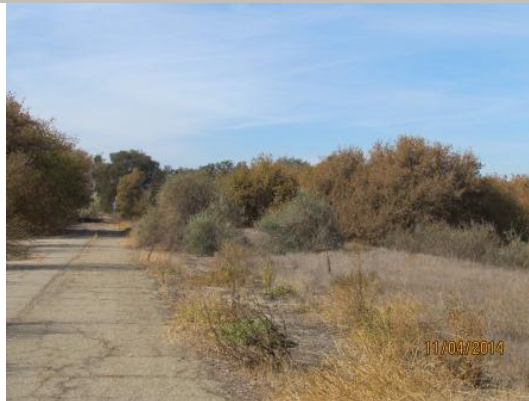
Photo 1 of 1 : SP\_2015\_RD2031\_308\_21\_20150317\_00008.jpg

View of overgrown vegetation on the levee crown.

LM Start	2.14	Rating **	M	Issue No.	21
LM End	2.14	Issue Type +	Ma	Location *	CR
Category	Earthen Levee			GPS Latitude/Longitude	
				Start	End
Item	Vegetation			37.640632 °	37.640632 °
				-121.221539 °	-121.221539 °
DWR ID	DWR_RD2031_02_f_2014_21				
Action/Comments					
Remove the wild growth other than native grasses from the levee slopes.

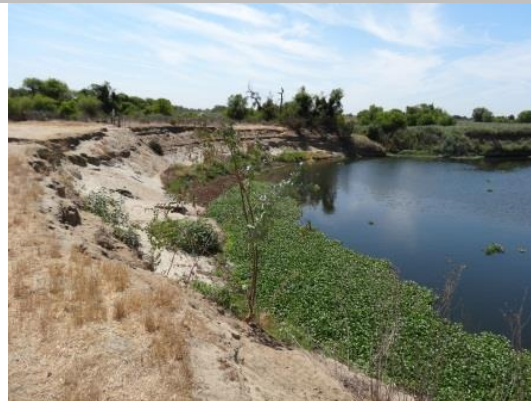
Photo 1 of 1 : SP\_2015\_RD2031\_308\_1\_20150317\_00001.jpg

LM Start	4.31	Rating **	A/W	Issue No.	1
LM End	4.31	Issue Type +	Ma	Location *	WS
Category	Supplemental			GPS Latitude/Longitude	
				Start	End
Item	DWR Erosion Survey			37.631716 °	37.631716 °
				-121.189370 °	-121.189370 °
DWR ID	DWR_RD2031_02_s _ 2015_1				
Action/Comments					
Inspector Comments: 7/17/2014: The erosion has slightly expanded toward levee toe at two pocket locations. 09/10/2013: The site has been visited. The erosion has expanded toward levee crest at two pocket locations. 07/18/2012: No significant change observed on the site. 08/18/2011: No significant change observed on the site. Dead trees and animal activities are visible. The closest point of the erosion site to the levee toe is about 100 ft. 10/19/2010: There is active scouring occurring on the bank due to the nature of the flow and the lack of armor protection. There is also a fallen log immediately downstream of where the erosion has occurred and is protruding outward, possibly creating an eddy and scouring the bank. With the remaining 100-foot wide berm, the levee prism is not yet affected. However, the bank will continue to degrade, and eventually intrude into the levee prism if no protection is put in place. Erosion site is recommended for annual assessment and monitoring during flood events. [2014 Site ID:RD2031U02RM78.7]

Looking downstream. The erosion has progressed toward levee.

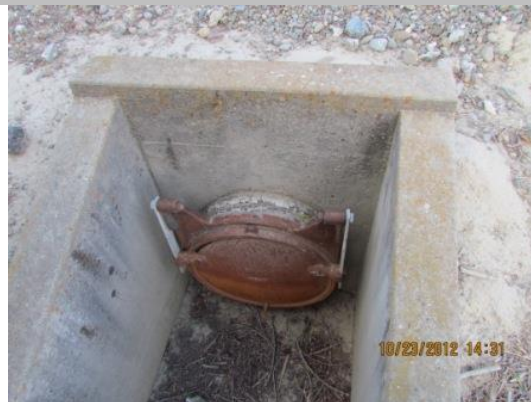
Photo 1 of 1 : SP\_2015\_RD2031\_308\_22\_20150317\_00009.jpg

LM Start	4.53	Rating **	A/W	Issue No.	22
LM End	4.53	Issue Type +	Ma	Location *	WS
Category	Earthen Levee			GPS Latitude/Longitude	
				Start	End
Item	Encroachments			37.630855 °	37.630855 °
				-121.185442 °	-121.185442 °
DWR ID	DWR_RD2031_02_f _ 2012_22				
Action/Comments					
Pipe					
Inspector Comments: 36" discharge pipe through the levee with flap gate closed.

View of the closed flap gate on waterside.
